# 3M ESPE Impression Tips

# Tearing/Rough Surfaces

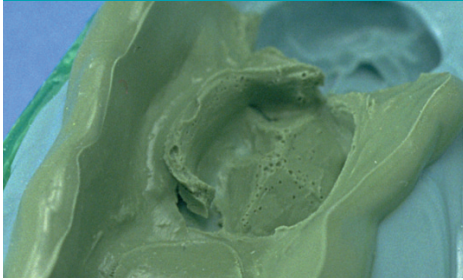
- Rough occlusal and/or incisal surfaces and tearing visible on the margin of the preparation (Photo).
- Poor lamination between tray material and wash may also be evident.

- Poor retraction technique.
- ■ Surface inhibition.
- ■ Moisture present.
- ■ Material slow setting (reason unknown).
- ■ Wash partially set at tray seating.
- ■ Early mouth removal.

- Improve retraction, and where appropriate, consider the two cord retraction technique.
- ■ Control bleeding and avoid pools of water or saliva on occlusal surfaces.
- ■ Replace via 3M ESPE Technical Hotline (1-800-634-2249).
- ■ Closely follow recommendations for oral work time.
- ■ Set a timer to ensure that the impression remains in the mouth for the full recommended set time.
